**FRACTOGRAPHY OF ADVANCED  
STRUCTURAL CERAMICS: RESULTS FROM  
THE VAMAS ROUND ROBIN EXERCISE**

**Report No. 19**  
**ISSN 1016-2186**  
**February 1995**

**Jeffrey J. Swab**  
U.S. Army Research Laboratory

**George D. Quinn**  
National Institute of Standards and Technology

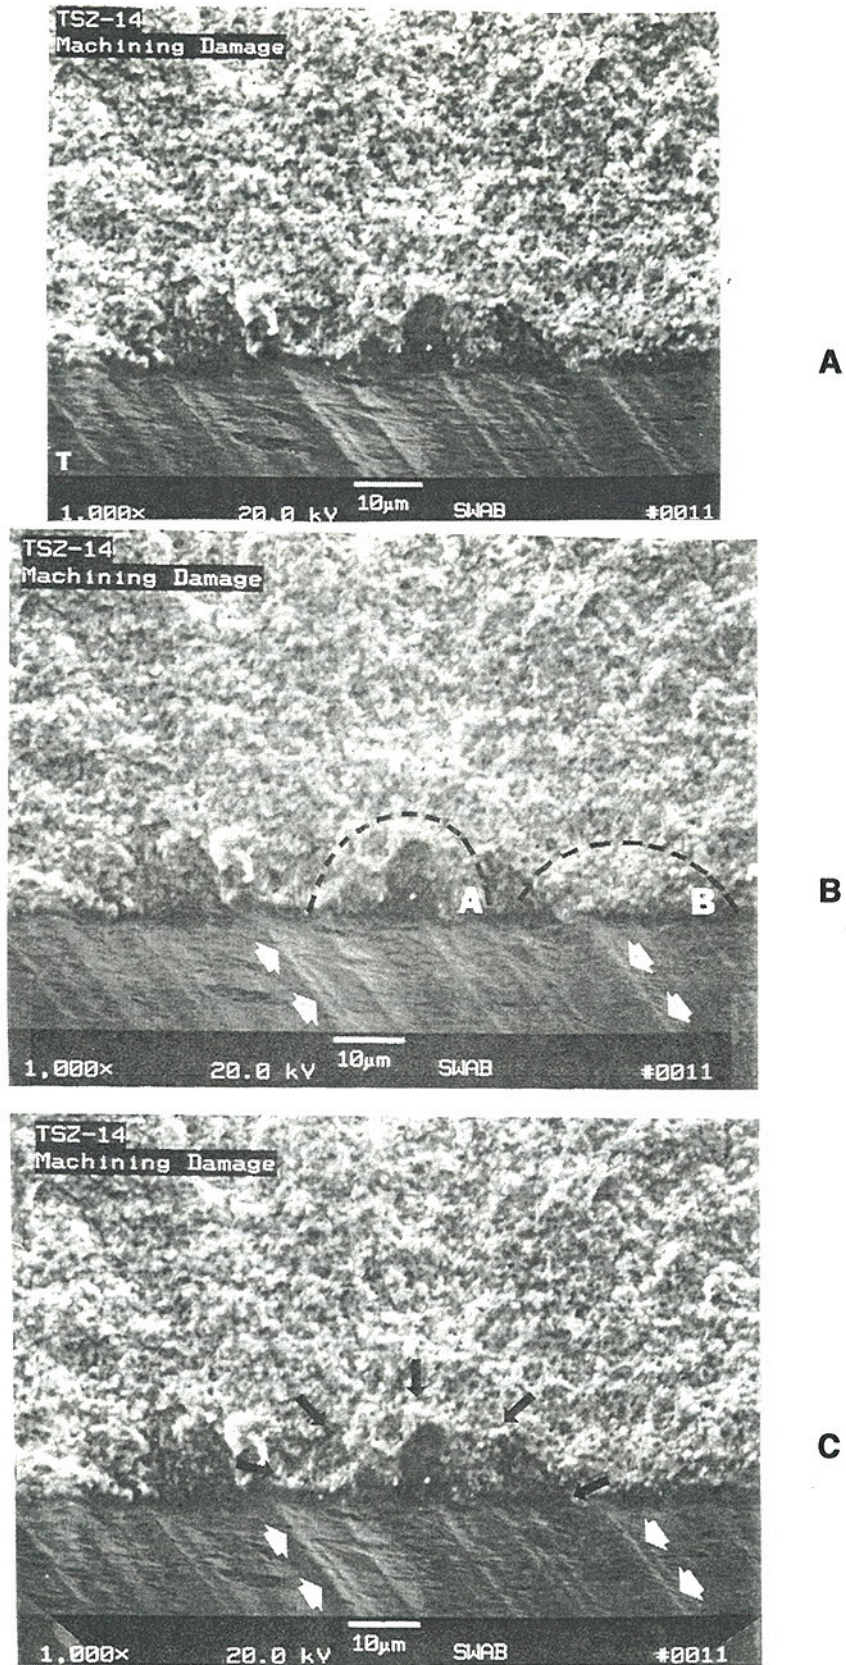
Figure 1.3. High magnification photographs of one half of the fracture surface from Set #1 (TSZ-14). A) Unmarked. B) The organizers outlined two possible semicircular origins. Arrows indicate possible striations on tensile surface. C) The organizers outlined a possible semielliptical origin. "T" denotes the tensile surface.

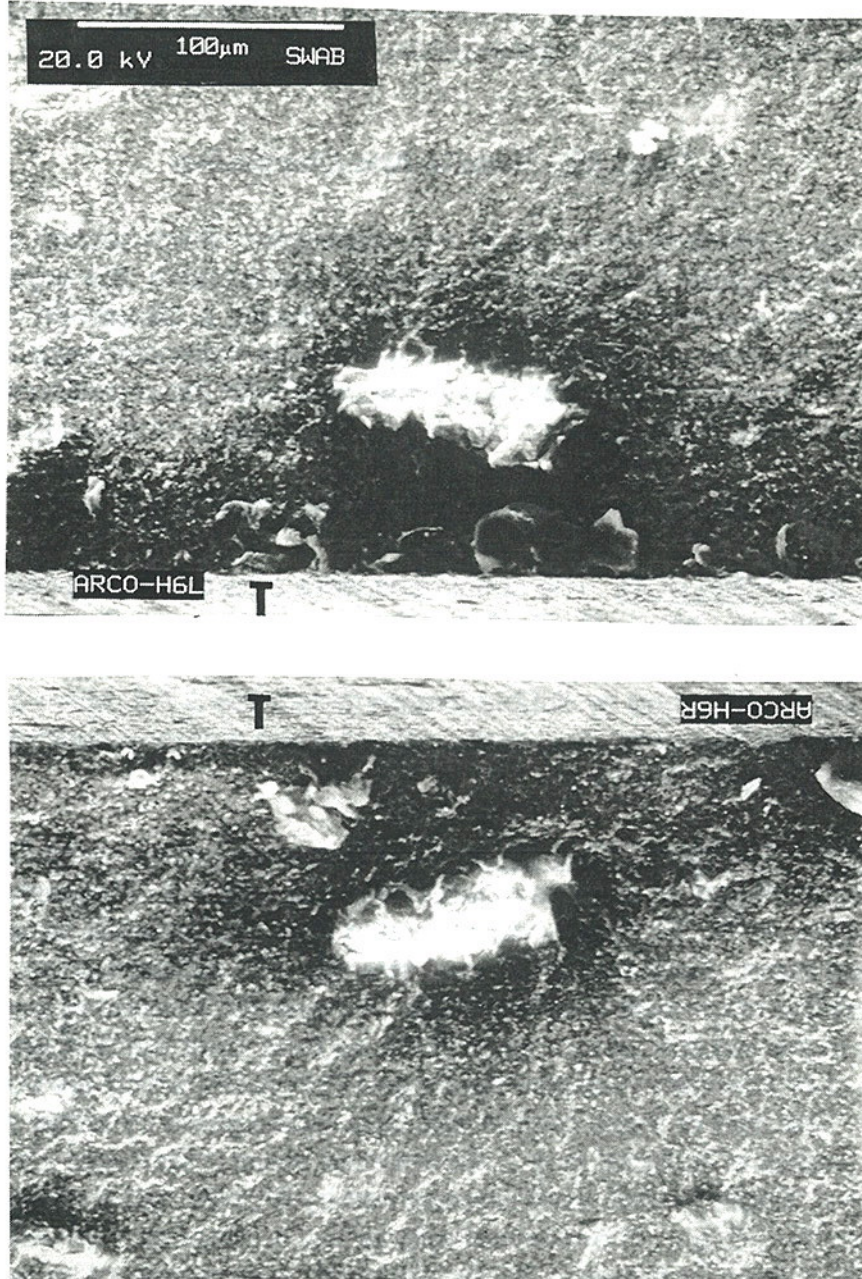
Figure 2.1.1. Example of Large Grains in Specimen 1: Alumina/SiC (whiskers). Mating halves of the primary fracture surface are shown. "T" denotes the tensile surface.

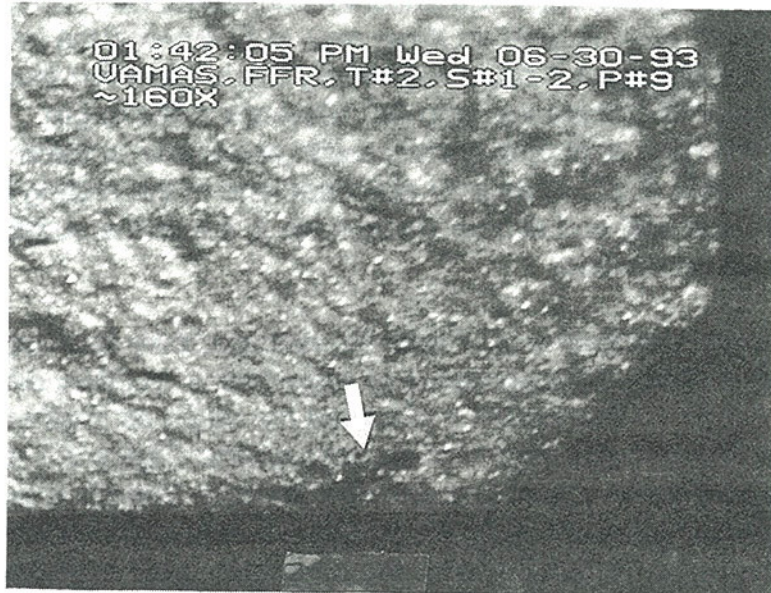
Figure 2.1.3. Optical photograph of alumina grains as the fracture origin in specimen #1. Origin appears as a dark spot when viewed optically. (Arrow added by the organizers.)

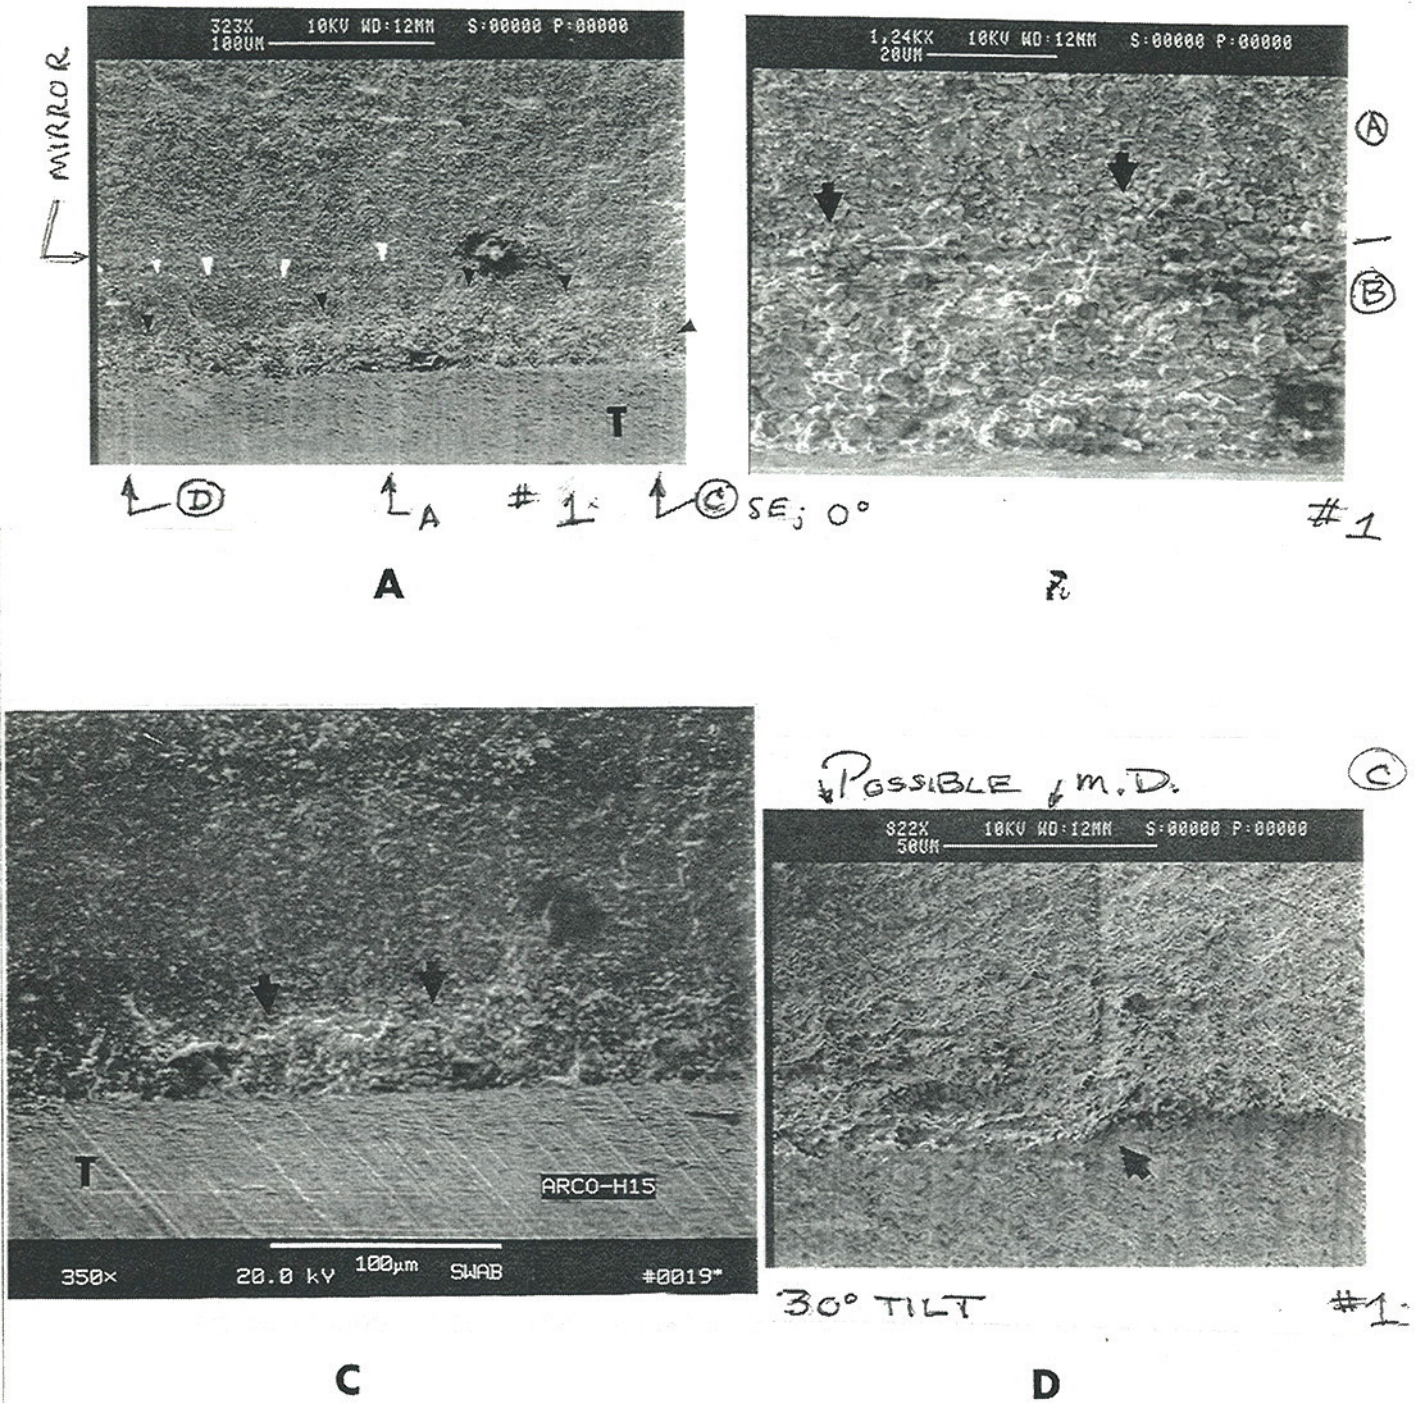
Figure 2.1.4. Photographs of large grain origin in specimen 1 from participant 4. A) and B) are the participants' photographs. Large grains can be seen in B). C) Organizers' photograph. "T" denotes the tensile surface. D) Participants' photograph of the possible machining damage. (Arrows in B and D were added by the organizers. Handwritten notes on A), B) and D) are the participants.)

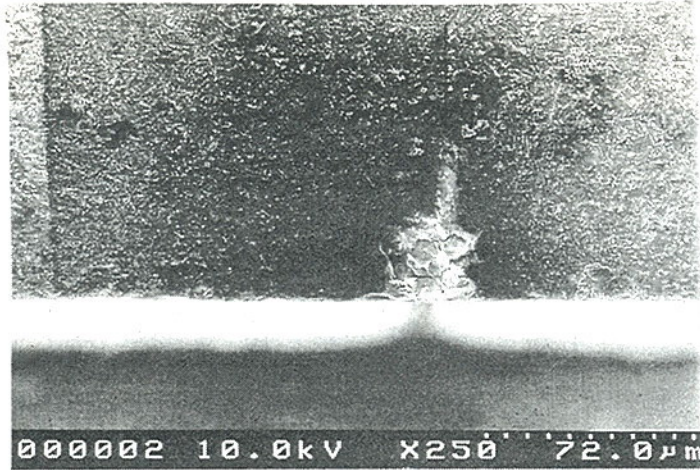
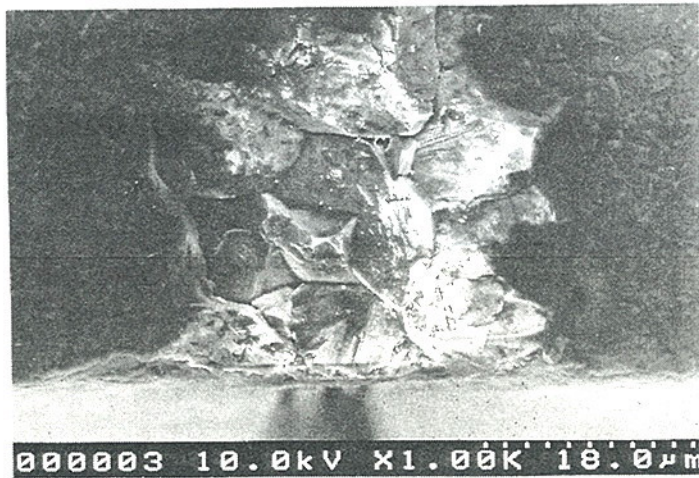
Figure 2.1.5. Two of participant 18's photographs of the origin in specimen 1. The origin is clearly located at the surface.

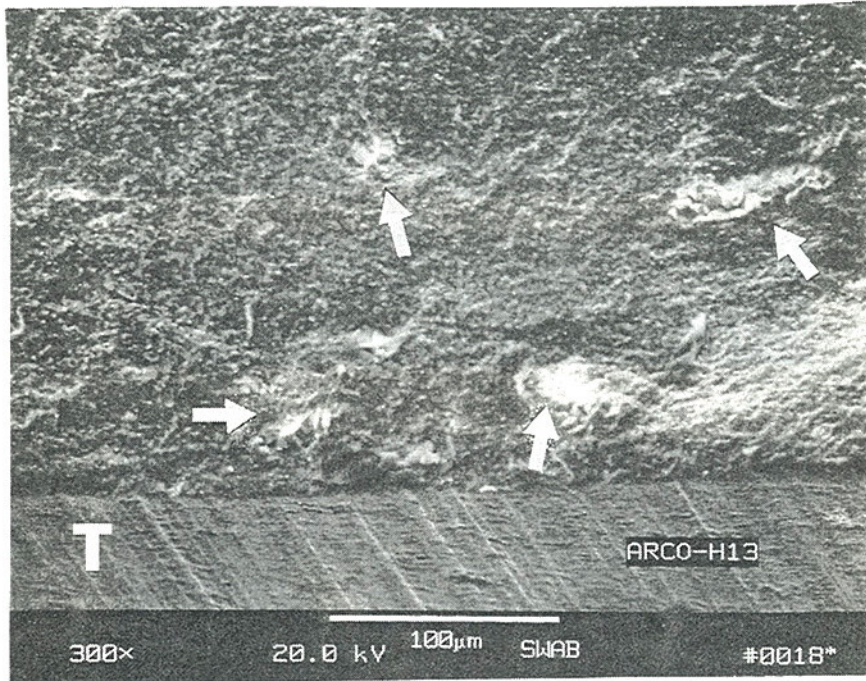
Figure 2.1.6. Organizers' SEM photograph showing several clusters of large alumina grains in specimen 1. "T" denotes the tensile surface.

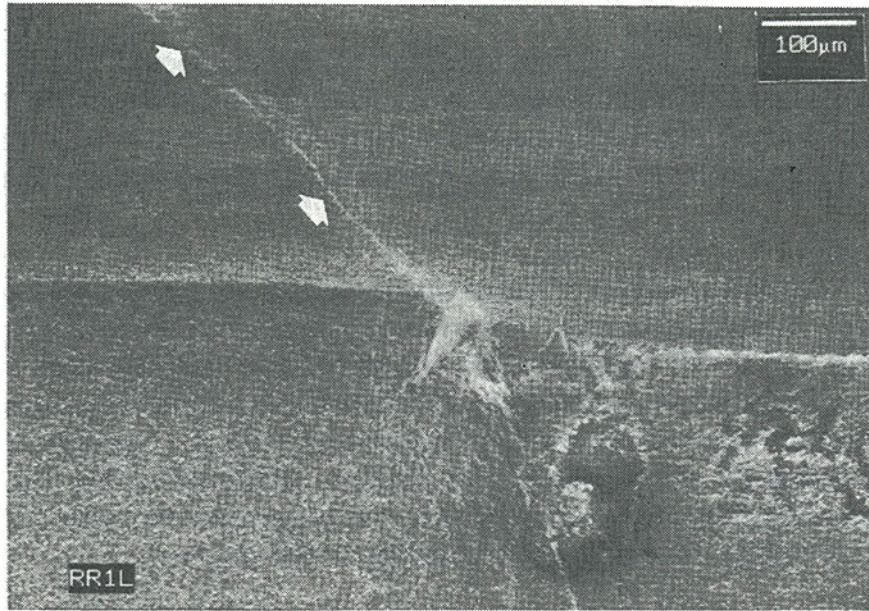
**Size** - Based on the given material properties and  $Y = 1.4$ , assuming a semicircular surface crack, the origin size should range from 38  $\mu\text{m}$  ( $\sigma = 466$  MPa) to 273  $\mu\text{m}$  ( $\sigma = 173$  MPa). It should be noted that the width of the gouge was approximately 10-30  $\mu\text{m}$ . The gouge itself is too small to be the origin. Therefore, there must be subsurface cracks, similar to machining damage, associated with the gouge. Over half of the participants reported a value within the origin size range while several others were close to this range and four did

Figure 2.2.1. Example of Handling Damage in Specimen 2: Alumina. "T" denotes the tensile surface.

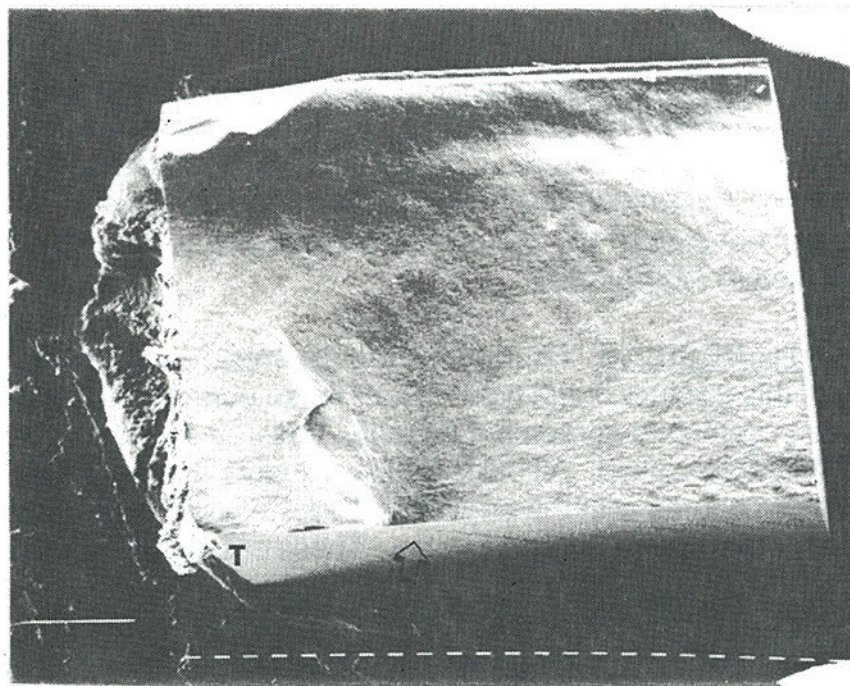
Figure 2.2.2. Participant 16's photograph of one of the mating halves of the primary fracture surface in specimen 2. The arrow was added by the organizers and points out the scratch (HD<sup>S</sup>) on the tensile surface (T).

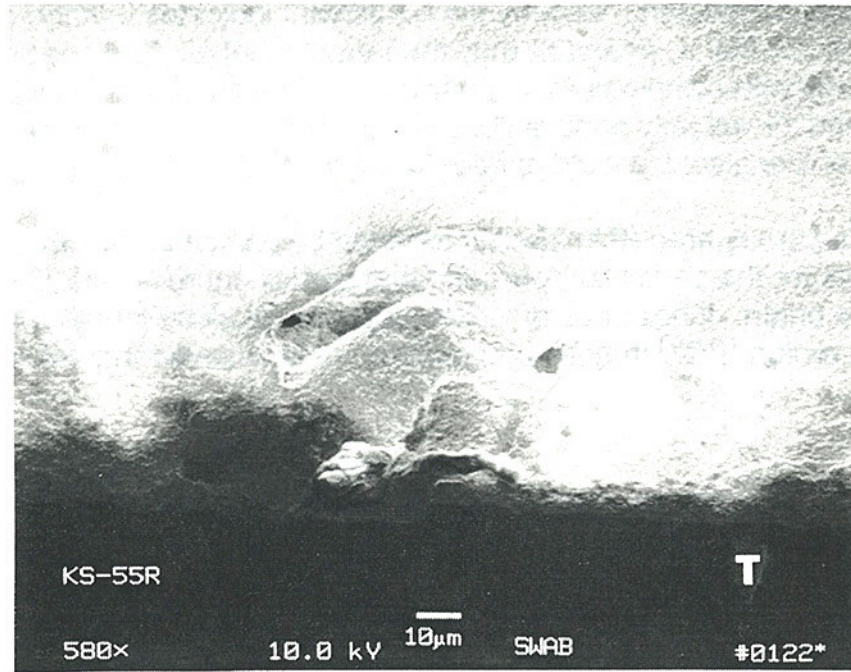
Figure 2.3.1. Example of a Pore in Specimen 3: Zirconia. "T" denotes the tensile surface.

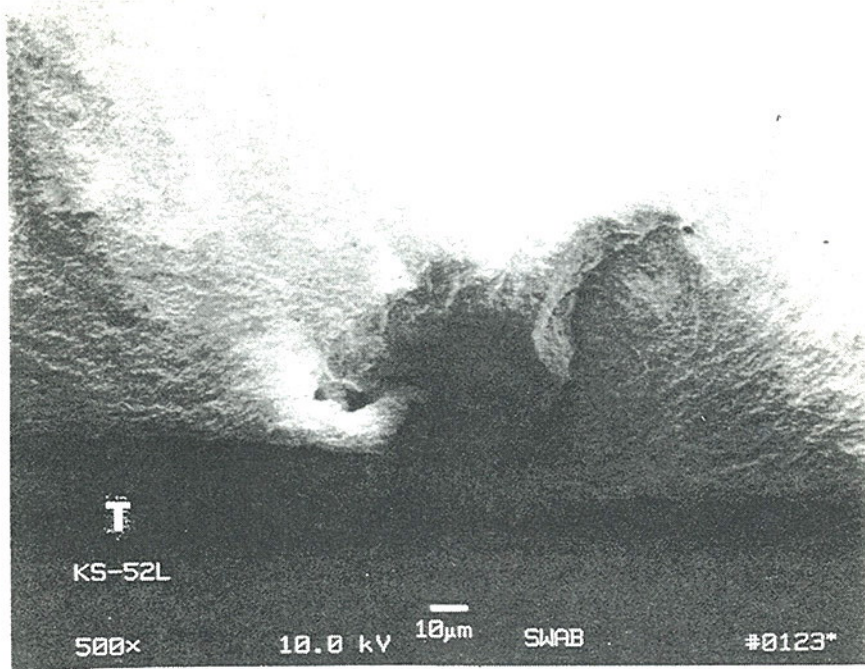
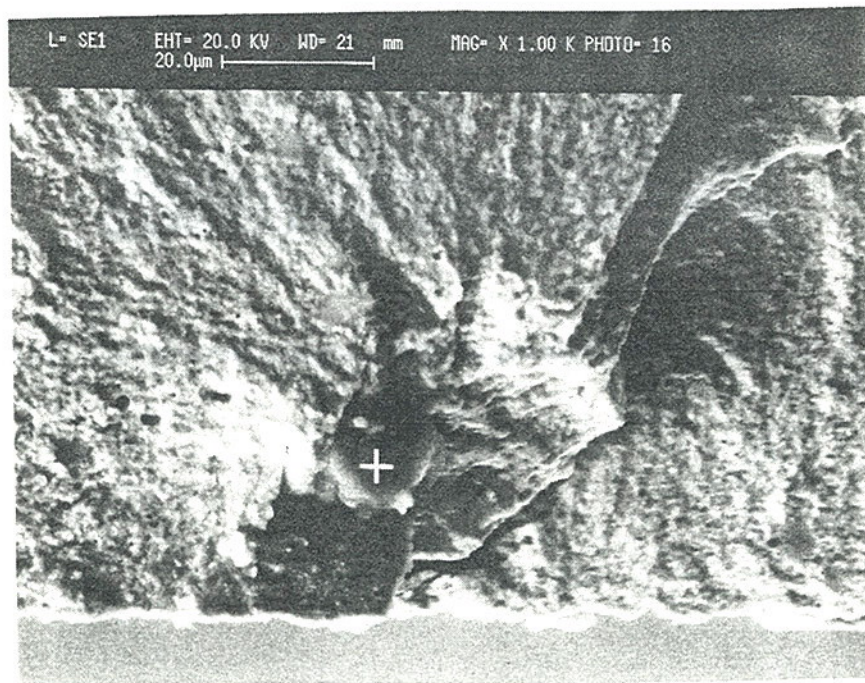
Figure 2.3.2. SEM photographs of the pore in specimen 3 from the set sent to participant 3. A) Organizers' photograph. "T" denotes the tensile surface. B) Participant 3's photograph. "+" indicates the "globule" where EDS was done.

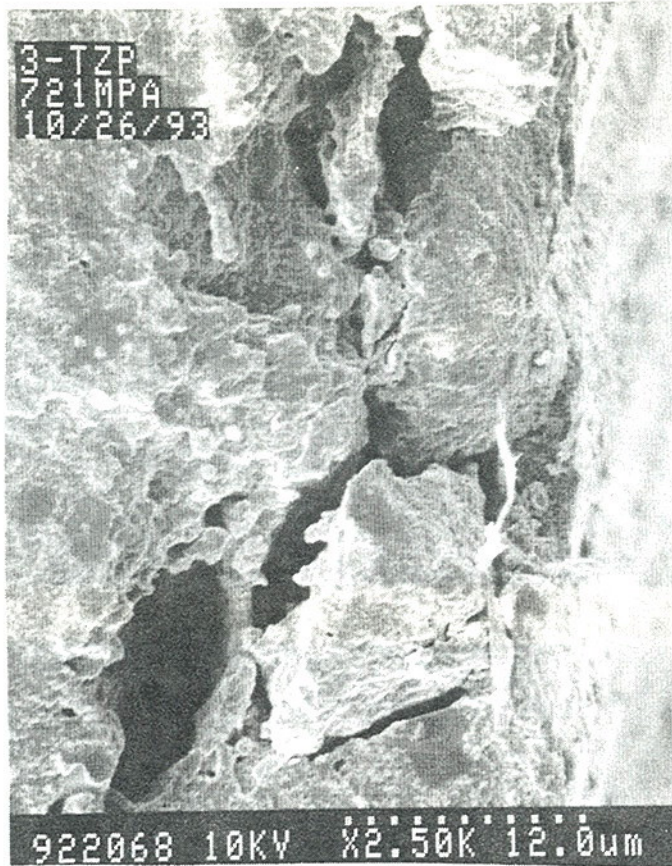
Figure 2.3.3. Participant 5's SEM photograph of the origin in specimen 3. Is this a pore or porous region?

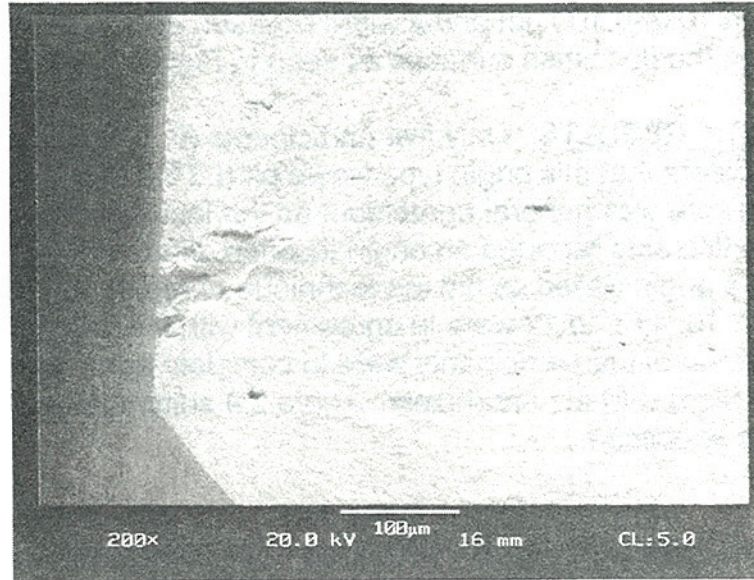
Figure 2.3.5. SEM photograph, from participant 7, of a pore located at the side of the flexure specimen. Appropriate location: Volume (V)\*. \* located at the side of the specimen approximately 175  $\mu\text{m}$  beneath the tensile surface.

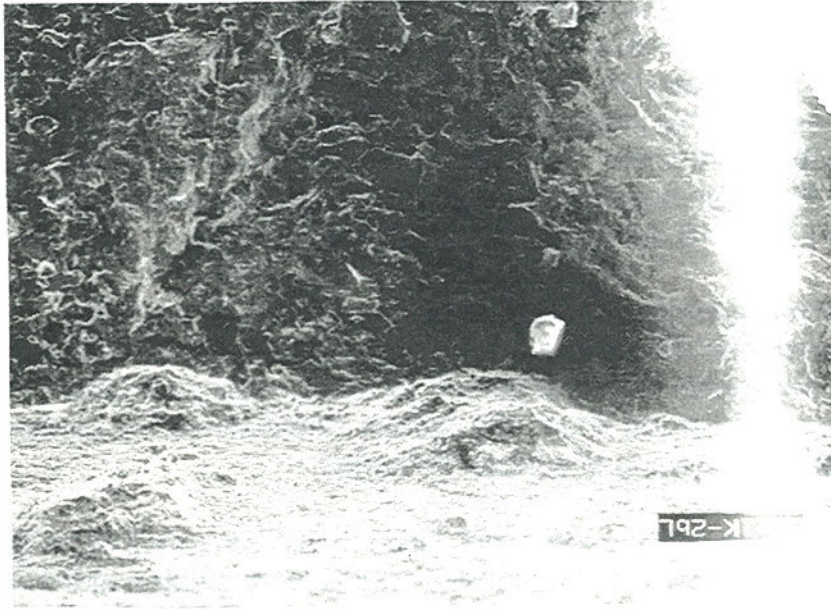
Figure 2.4.1 Example of Pits in Specimen 4: Silicon Carbide. "T" denotes the tensile surface.

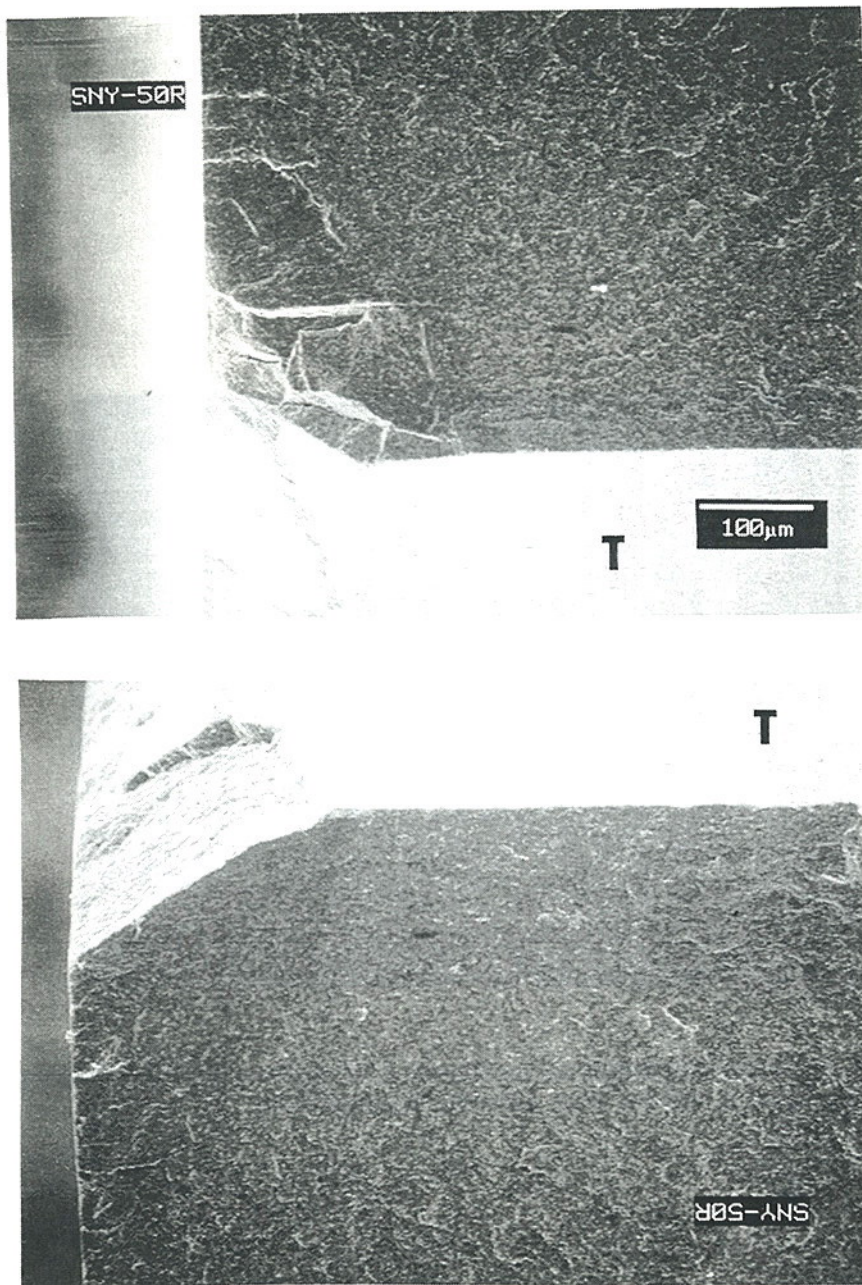
Figure 2.5.1. Example of Machining Damage in Specimen 5: Silicon Nitride. Mating halves of the primary fracture surface are shown. "T" denotes the tensile surface.

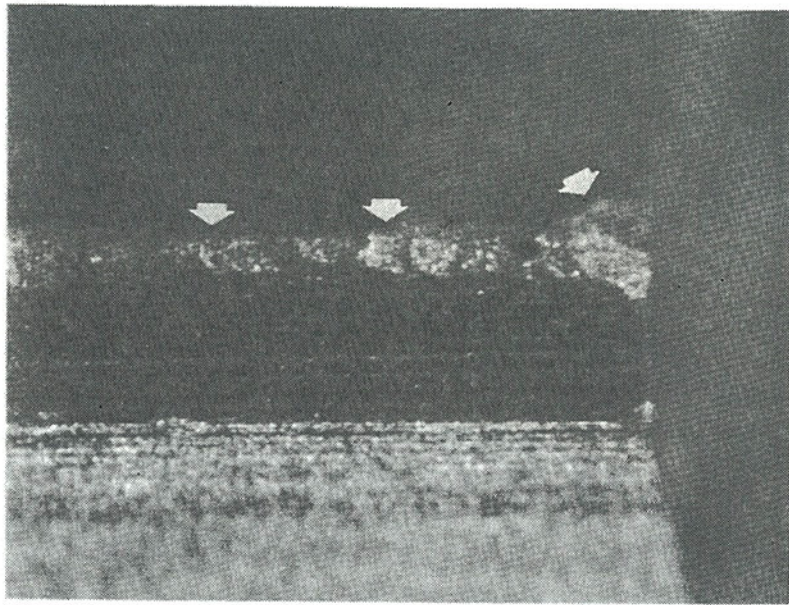
Figure 2.5.2. Optical photograph from participant 4, of machining related chipping on the chamfer of specimen 5. Arrows were added by the organizers.

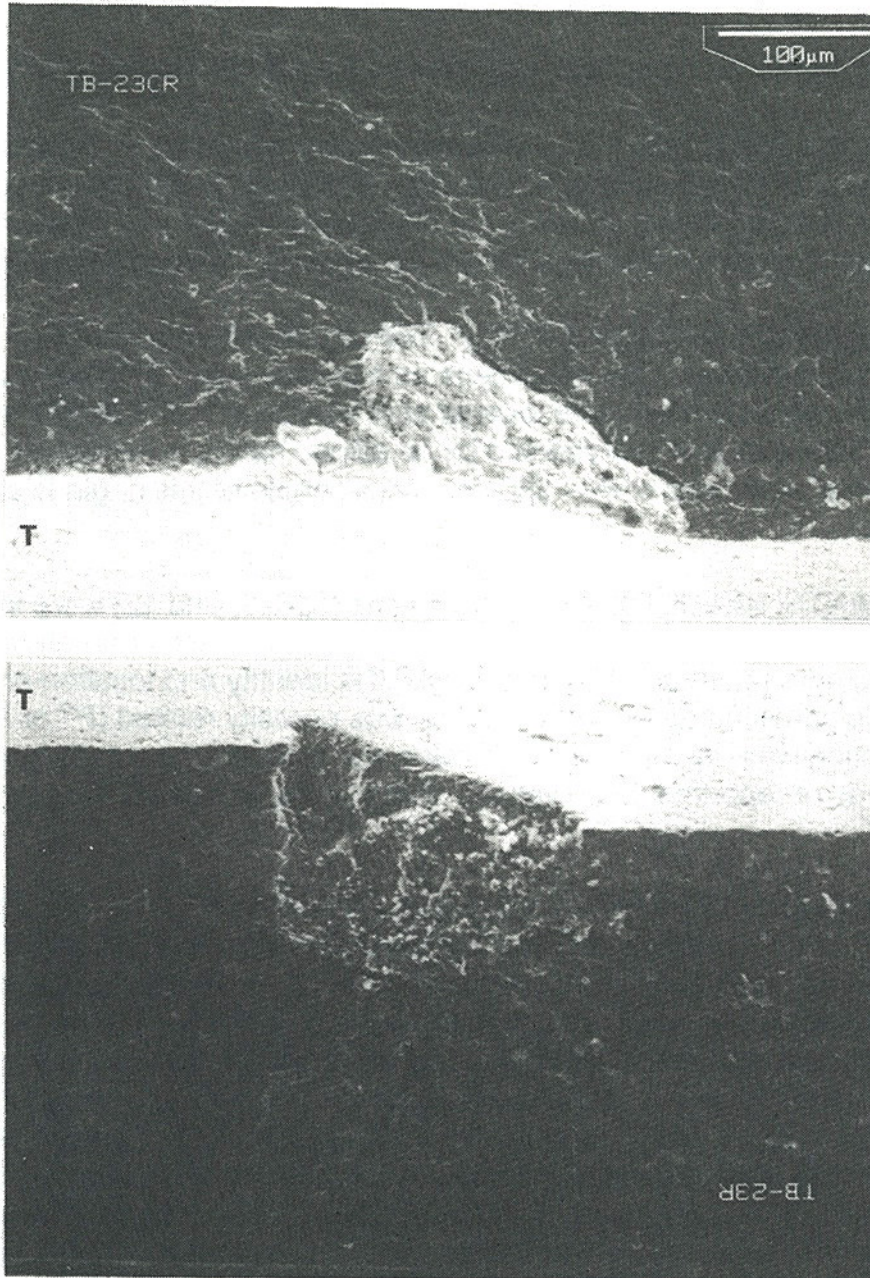
Figure 2.6.1. Example of Porous Seam/Porous Region in Specimen 6: Titanium Diboride. Mating halves of the primary fracture surface are shown. "T" denotes the tensile surface.

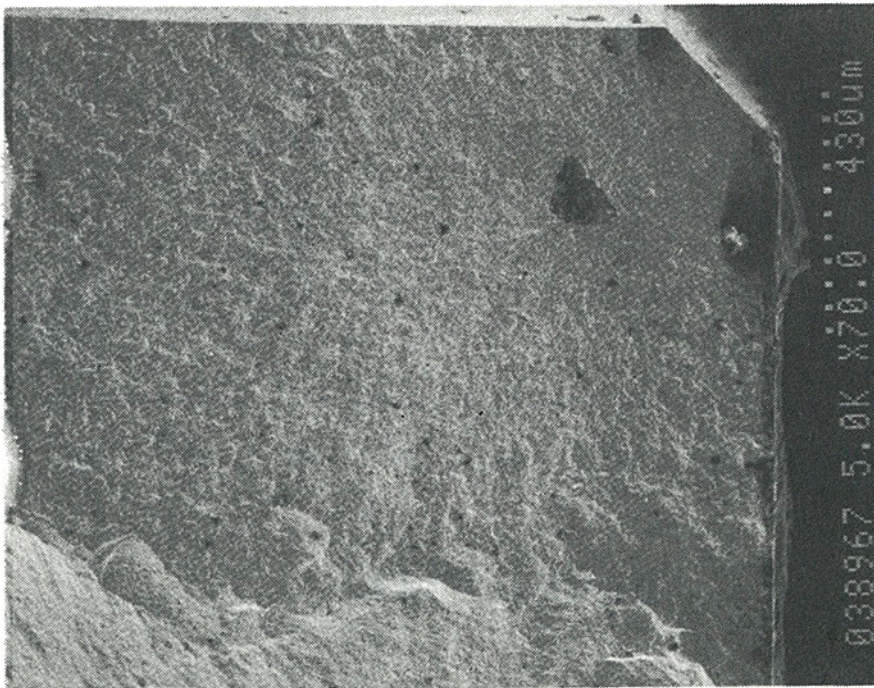
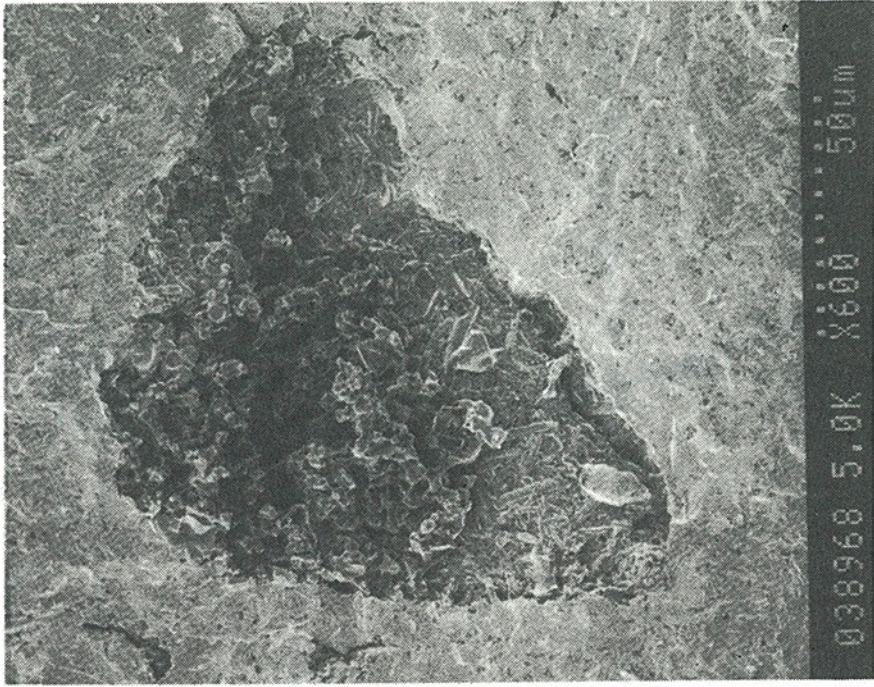
Figure 3.2. Example of the fracture origin, pore ( $P^V$ ), seen in the  $\beta$ -SiC analyzed by Participant 2. A) 70X. B) 600X.

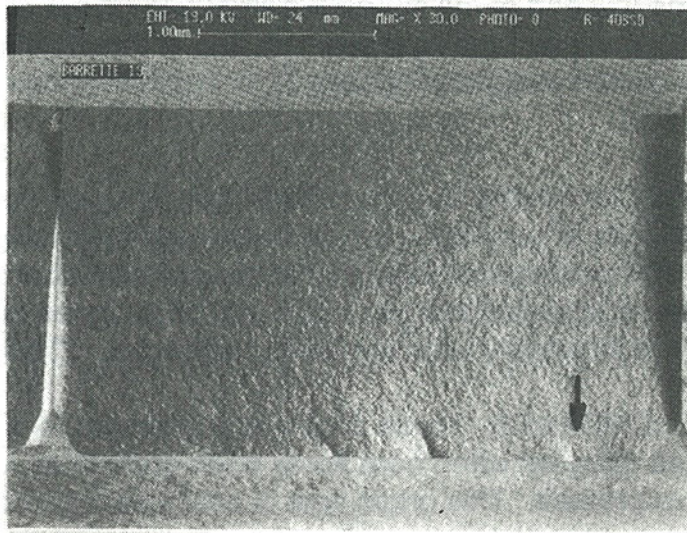
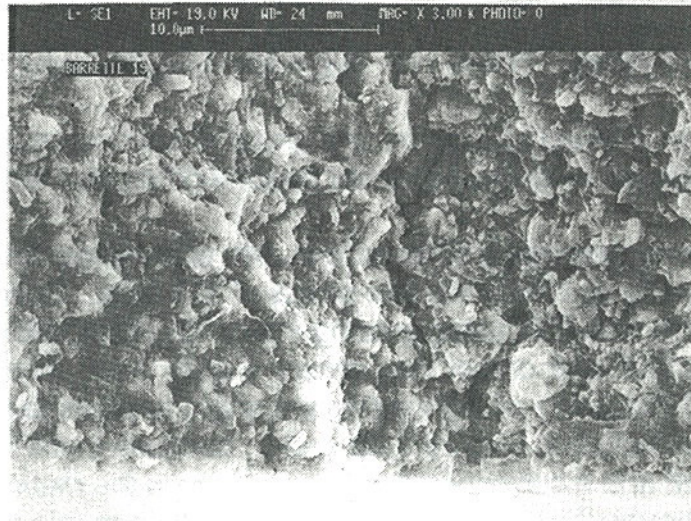
**SAMPLE N° 19**

Figure 3.6. Example of an origin in a  $\text{Si}_3\text{N}_4/\text{TiN}$  specimen. Labeled by participant 10 as a crack.
