**VAMAS TWA 22
Mechanical Property
Measurement of Thin
Films and Coatings**

**A ROUND ROBIN TO
MEASURE THE
ADHESION OF THIN
COATINGS**

September 2004

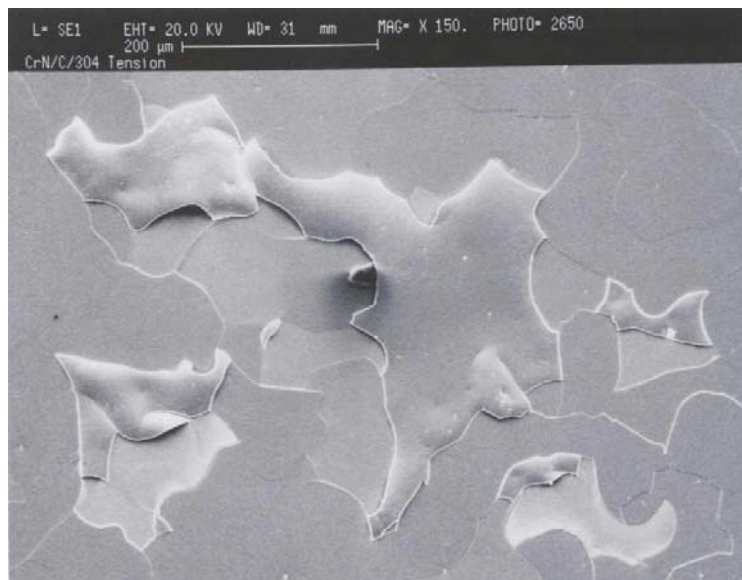
Figure 1. CrN coating on AISI 304 stainless steel with carbon interlayer. Coating spallation induced by differential thermal expansion coefficients when cooling from deposition temperature.

A scoping study was undertaken at NPL prior to the ILE to test the sample response to different adhesion tests and to aid the writing of a common test proforma to be used by all participants. Adhesion tests undertaken with titanium nitride on AISI 304 stainless steel found that this material combination was unsuitable for an ILE due to the very high adhesion and low fracture toughness of the coating, which made it difficult to observe any delamination unless extreme stresses were applied. To improve the chance of observing adhesive failure a less adherent and/or higher fracture toughness CrN coating was chosen.

Adhesion of CrN was controlled using a thin interlayer. For the scoping study two interlayers were designed to reduce adhesion. An Au/Pd (60:40 wt.%) interlayer was intended to provide a ductile region between coating and substrate and disrupt any chemical bonding between coating and substrate. This was deposited on polished coupons using a small sputter chamber designed to apply conductive coatings for scanning electron microscopy (SEM) specimens. Coating thickness was measured gravimetrically at ~35nm. The second interlayer was an amorphous carbon layer again used to contaminate the interface and reduce chemical and mechanical bonding. The carbon interlayer was deposited using a carbon arc evaporator, similarly designed for SEM work. Several arc pulses were required to get a visible coating. After deposition of the CrN coating on the carbon interlayer large scale delamination of the coating from the substrate was observed. The carbon interlayer had reduced adhesion so much that when cooling from deposition temperature the differential thermal contraction of the coating and substrate was enough to cause the coating to spall (**Figure 1**). The Au/Pd layers did not result in spallation. Rockwell indentation and 4 –point bend testing showed some differences in coating adhesion. Therefore the Au/Pd interlayer was chosen for the ILE coupons and the thickness was varied to obtain different adhesion levels. It was hoped that the ILE test results would allow discrimination between coatings with and without an interlayer and between the different interlayer thicknesses.
