**FRACTOGRAPHY OF ADVANCED  
STRUCTURAL CERAMICS: RESULTS FROM  
THE VAMAS ROUND ROBIN EXERCISE**

**Report No. 19**  
**ISSN 1016-2186**  
**February 1995**

**Jeffrey J. Swab**  
U.S. Army Research Laboratory

**George D. Quinn**  
National Institute of Standards and Technology

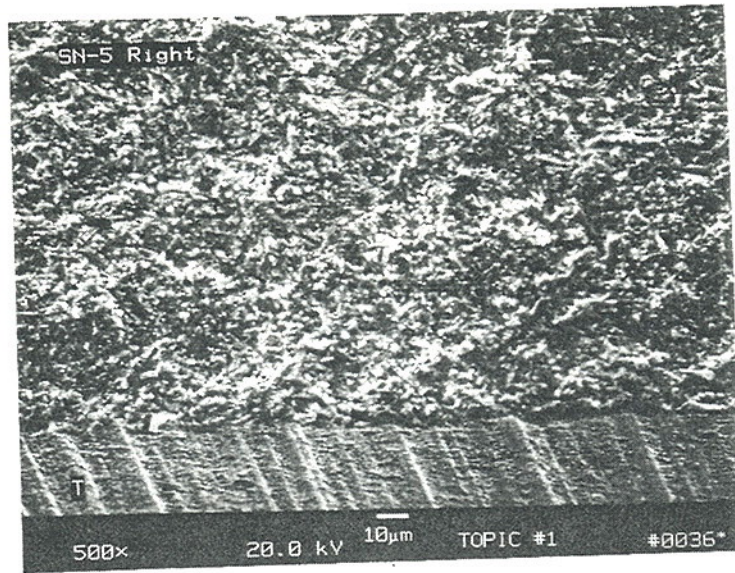
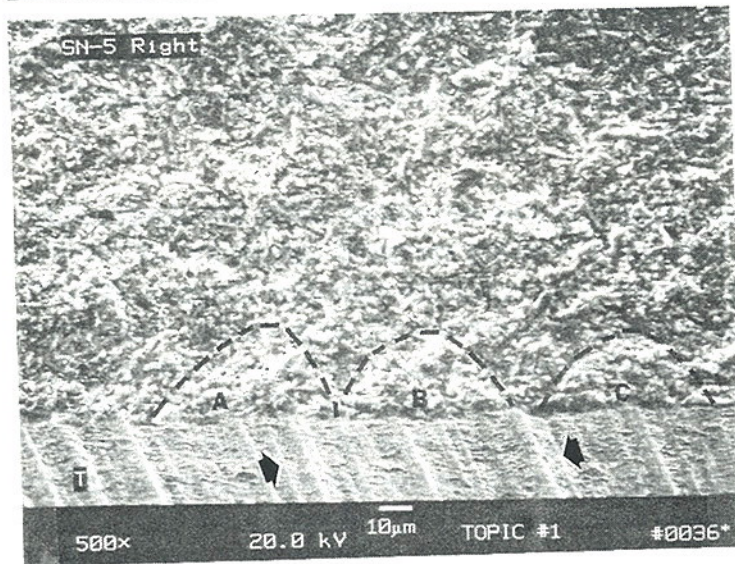
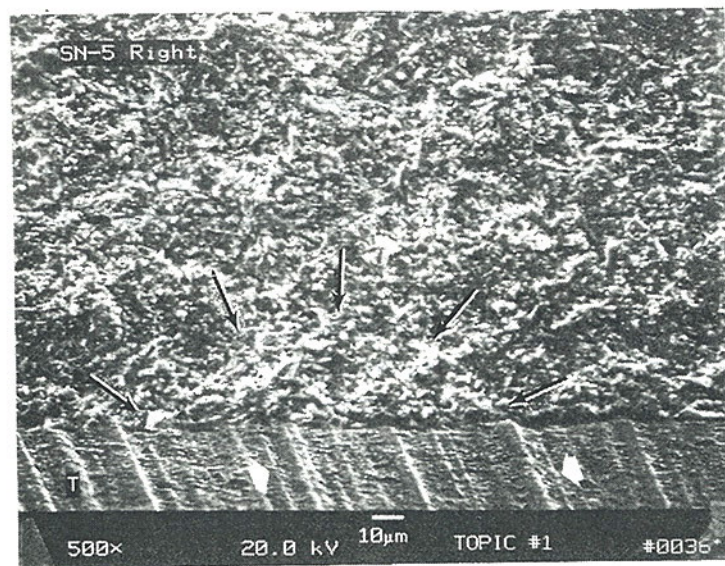
ORGANIZERS' CHARACTERIZATION - Machining damage was identified by the organizers as the fracture origin in this specimen. Several semicircular and semielliptical subsurface cracks are outlined by the organizers in Figures 1.5B and 1.5C, respectively, as the possible machining damage. All are equally plausible interpretations of the fracture origin. The semielliptical crack in Figure 1.5C may be a linked set of semicircular cracks. The depth of the crack of either geometry was  $\approx 25 \mu\text{m}$ . Complete characterization of the fracture origin is:

Figure 1.5. High magnification photographs of one half of the fracture surface from Set #2 (SN-5). A) Unmarked. B) The organizers outlined three possible semicircular origins. Arrows indicate possible striations on tensile surface. C) The organizers outlined a possible semielliptical origin. "T" denotes the tensile surface.

In set #2 (Silicon Nitride) the organizers feel the machining damage also had a semicircular or semielliptical shape. An alternate interpretation is that several small semiellipses merged into one larger one as illustrated by the dashed line in Figure 1.5C. Such linking has been reported previously<sup>30</sup>. Three subsurface cracks can clearly be seen in Figure 1.5B. All three are approximately the same size but the crack labeled B is centered in the fracture mirror. Participants 4 and 11 stated that these origins looked like "controlled surface flaws".

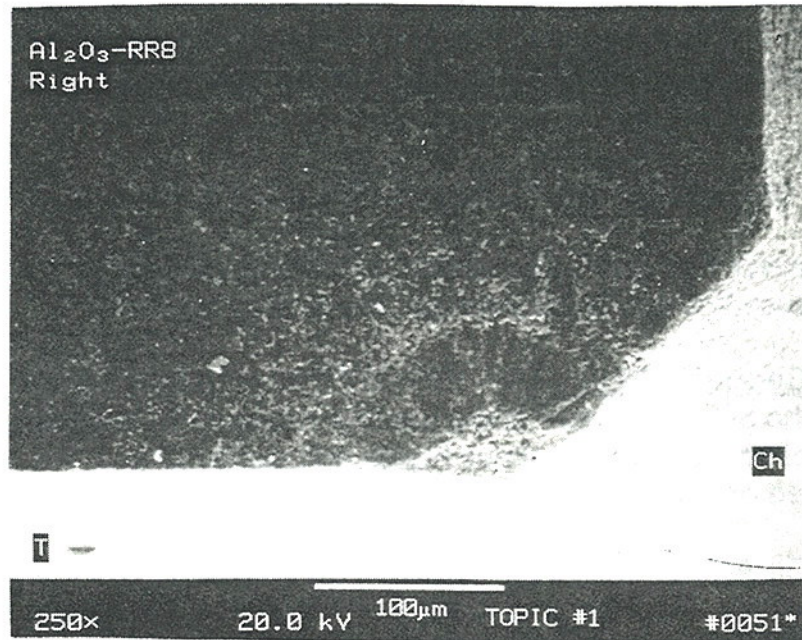
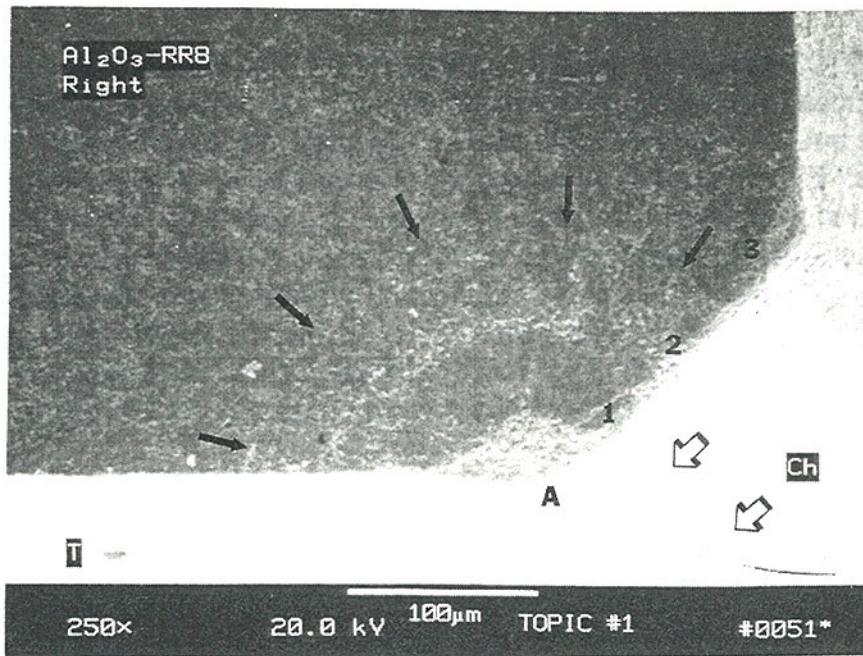
Figure 1.7. High magnification photographs of one half of the fracture surface from Set #3 ( $\text{Al}_2\text{O}_3\text{-RR8}$ ). A) Unmarked. B) Three stages of fracture are outlined by the organizers. Stage 1 is transgranular fracture, Stage 2 is subcritical crack growth and Stage 3 is fast fracture. Open arrows indicate the irregular section of the chamfer. "T" denotes the tensile surface and "Ch" the chamfer.

None of the participant noted the irregular edge along the chamfer in set #3 (Alumina), open arrows in Figure 1.7B. The chamfer is irregular and comprised of several segments at different angles. This feature did not copy well in the photographs sent to the participants and probably accounts for the oversight. This fracture origin may be a case of coincidental origin types, a porous region plus machining damage.

The shape of the fracture origin in set #3 (Alumina), Figure 1.7B is clearly part of a circle. Because the origin is located at or near the edge some participants were unsure as to how to measure it. Some measurements were made across the corner (chamfer), or on a radius running perpendicular from point A, see Figure 1.7B, into the bulk, still others made their measurements from point A along the tensile/fracture surface interface. One participant felt that special instructions should be provided to measure the origin size in such cases. The simplest way is to extend the plane of the tensile surface and extrapolate the arc of the semicircle from the edge to this extension, completing the semicircle.

The edge crack in the alumina specimen (set #3) had a number of interesting features. As outlined in Figure 1.7B there appears to be three stages of crack growth. Stage 1 is transgranular fracture which may have occurred due to machining. Stage 2 is more intergranular and may indicate subcritical crack growth. Stage 3 could be fast fracture. The time-to-failure in the strength test was approximately 7 seconds. (The specimen was tested in laboratory ambient conditions in which humidity may have had an affect.) Kirchner, et. al.<sup>19</sup> have seen similar types of fractures in 96%  $\text{Al}_2\text{O}_3$  specimens. Application of

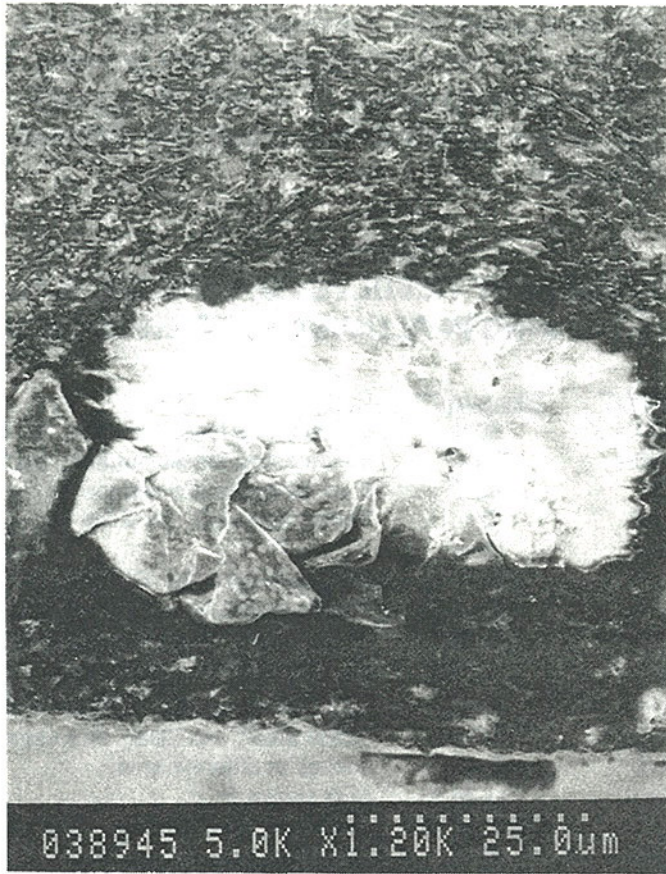
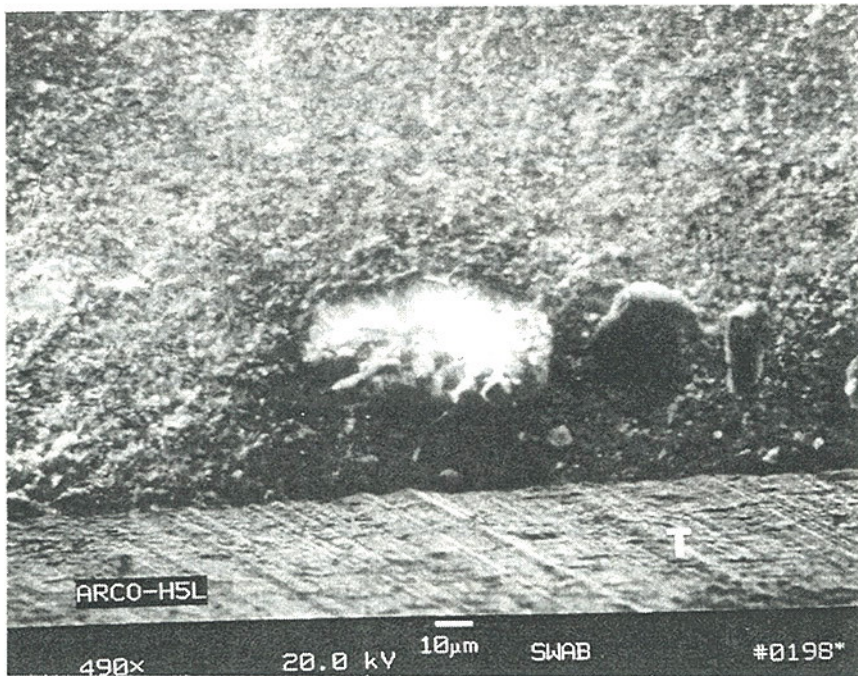
One is the failure to use EDS to analyze the chemical composition of the origin. Participants 2 and 11 labeled the origin as an inclusion (IV). Neither participant used EDS. In both cases the organizers' and participants' photographs of the origin are identical. Figure 2.1.2 shows the participants' and the organizers' photographs of the origin in participant 2's specimen. EDS of these origins by the organizers revealed a high Al content with no Si. This indicates that the origin may be large alumina grains. Another reason for the inclusion label could be the appearance of the large  $\text{Al}_2\text{O}_3$  grains when viewed

Figure 2.1.2. Photographs of large grain fracture origin in specimen 1 from participant 2 specimen set. A) Participants' photograph. B) Organizers' photograph. "T" denotes the tensile surface in B).

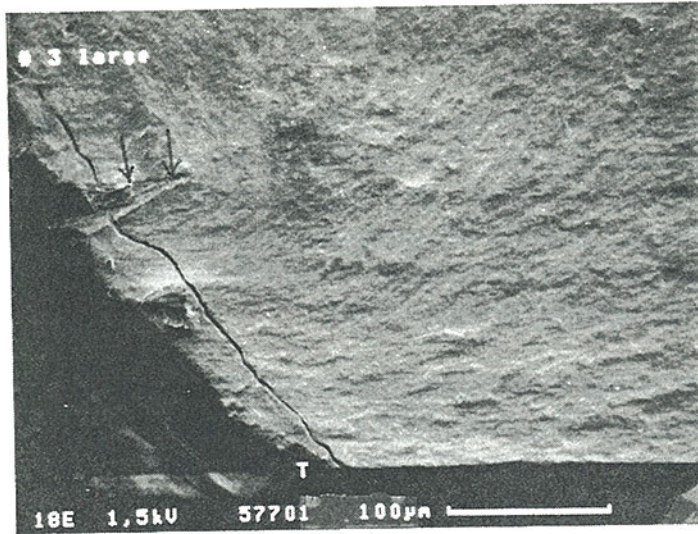
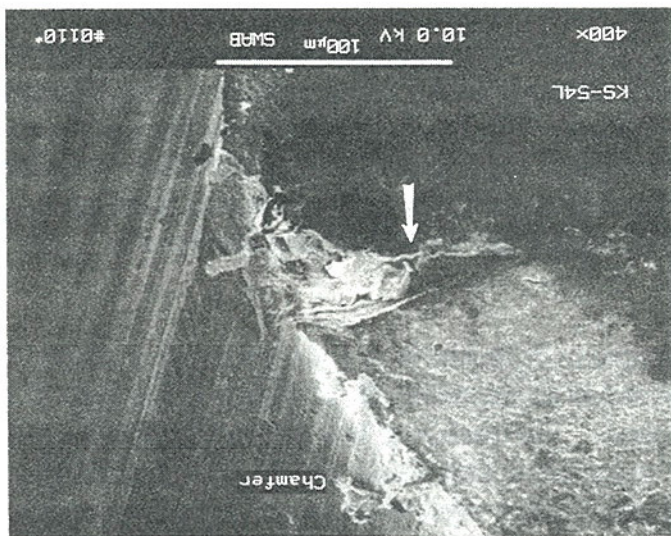
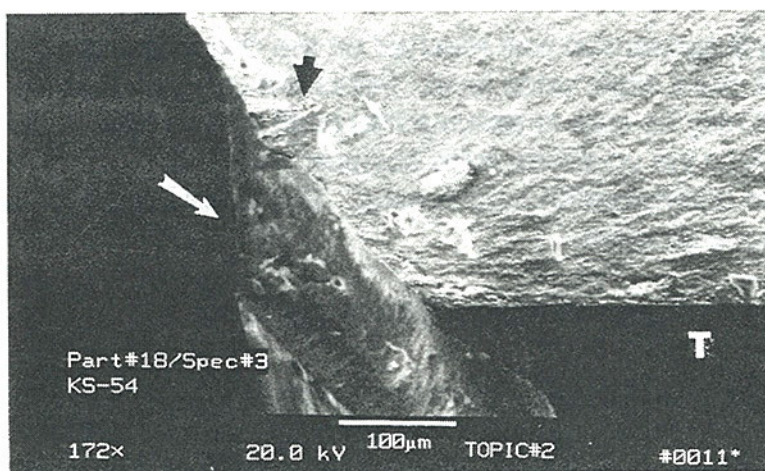
Figure 2.3.4. SEM photographs of specimen 3 from the set sent to participant 18. A) Participant 18's photograph. The participant used hand drawn arrows to show the pore. B) SEM photograph taken by the organizers' prior to sending the specimen to the participant. C) Organizers' SEM photograph of the fracture origin after it was characterized by the participant and returned to the organizers. Black arrow indicates the pore and white arrow shows where the piece was removed. "T" denotes the tensile surface.

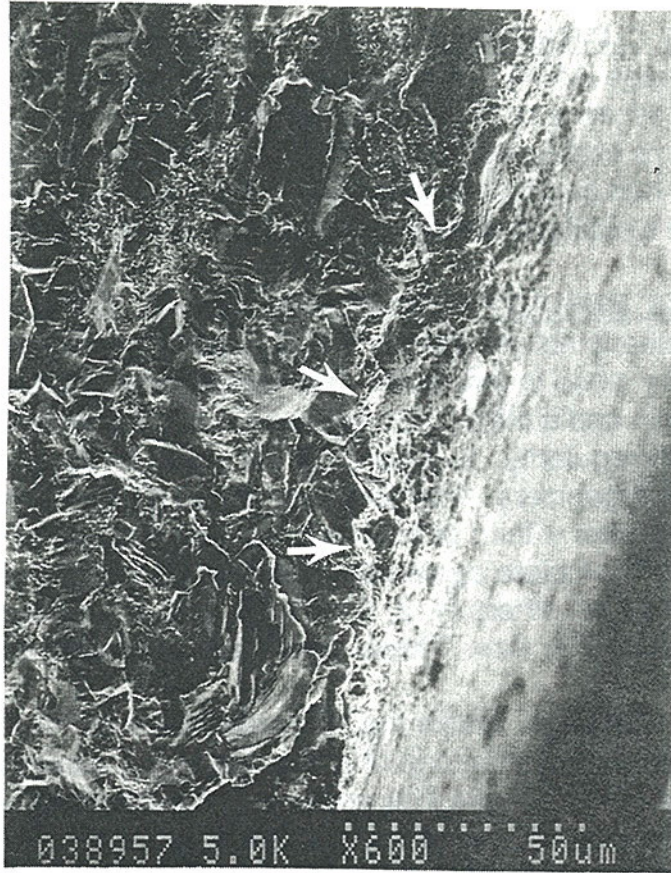
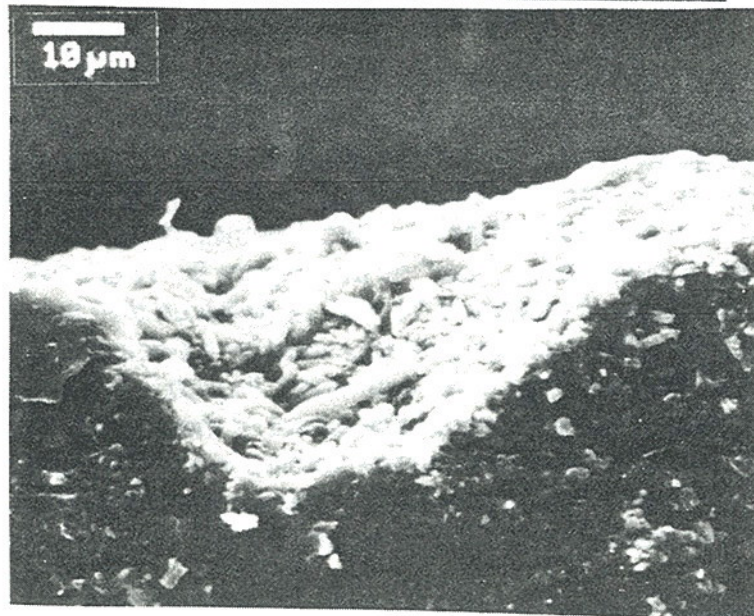
Figure 2.4.2. A) Participant 2's SEM photograph of the pit in specimen 4. Arrows added by the organizers. B) SEM photograph of a surface void from Military Handbook 790, Figure 33, page 40. Note the similarity.

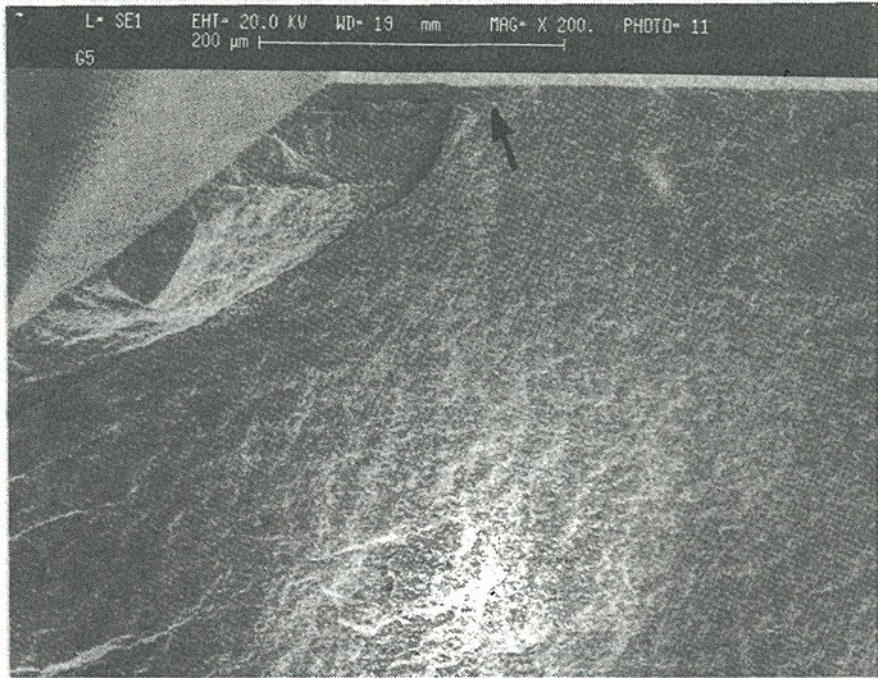
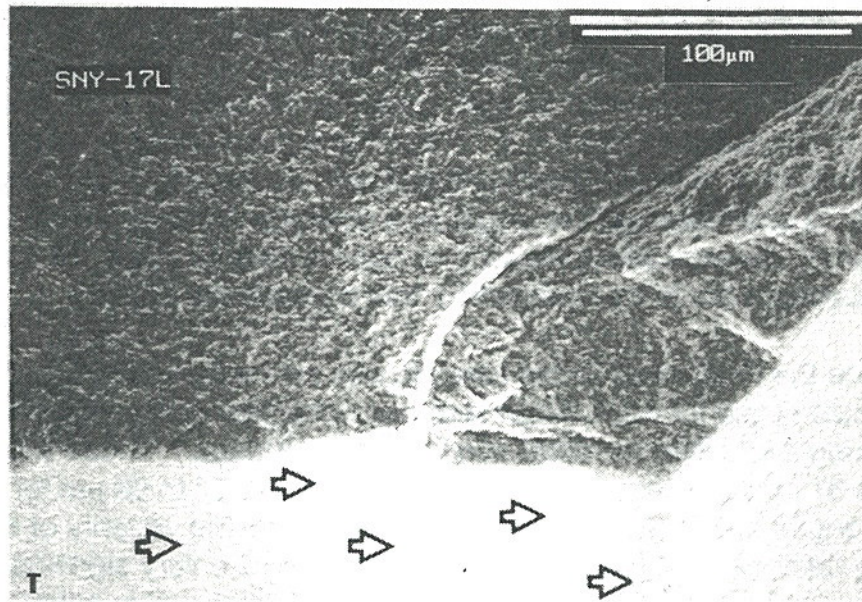
Figure 2.5.3. SEM photographs of specimen 5. A) Participant 10's photograph. B) Organizers' photograph. Arrows point out the machining damage on the tensile surface. "T" denotes the tensile surface.

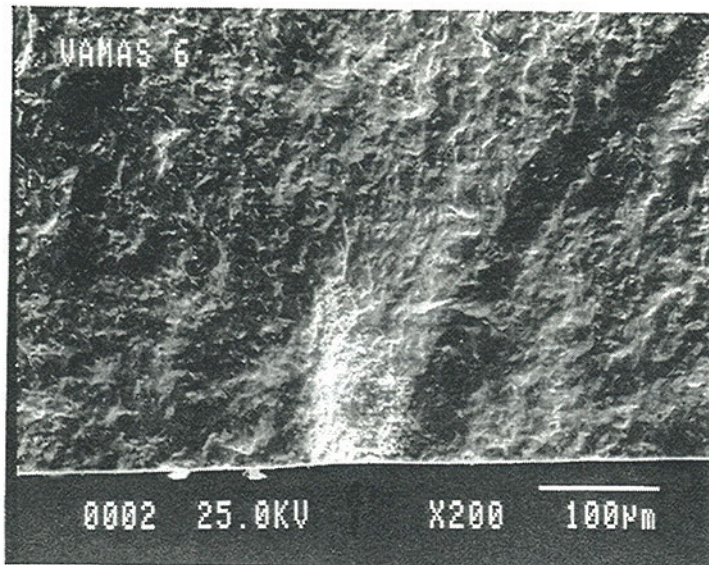
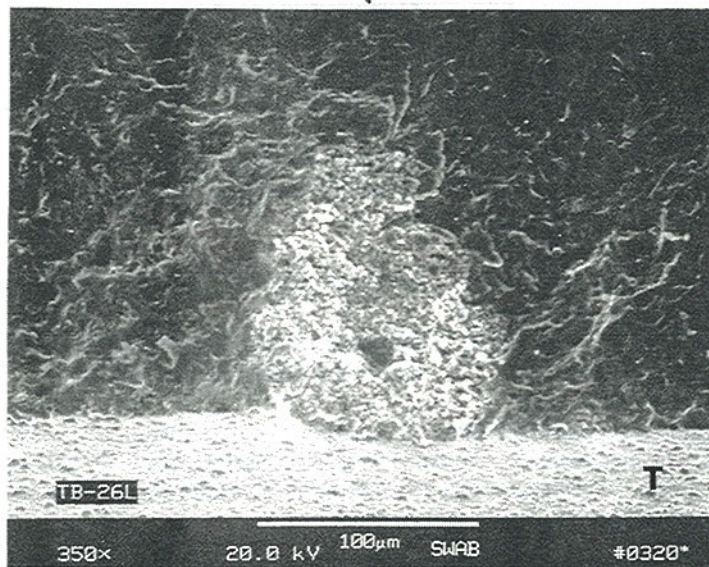
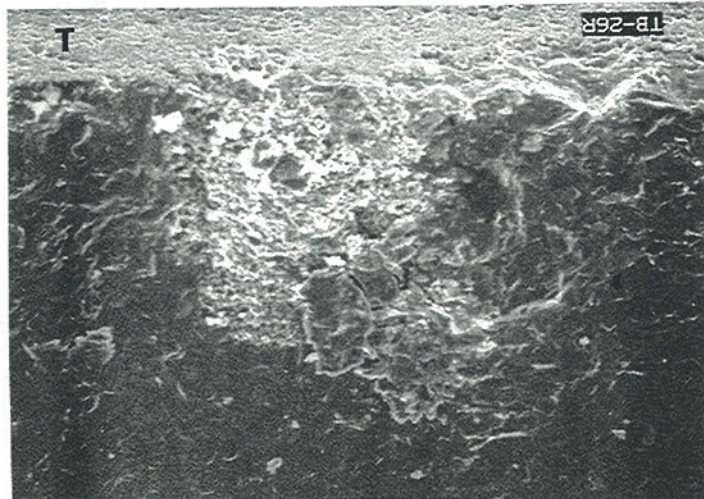
Figure 2.6.2. SEM photographs of specimen 6. A) Participant 15's photograph. B) Organizers' photographs of the mating halves of the primary fracture surface. The photographs in B) indicate that this origin is a porous region (PR<sup>V</sup>) and not an agglomerate (A<sup>V</sup>). "T" denotes the tensile surface.

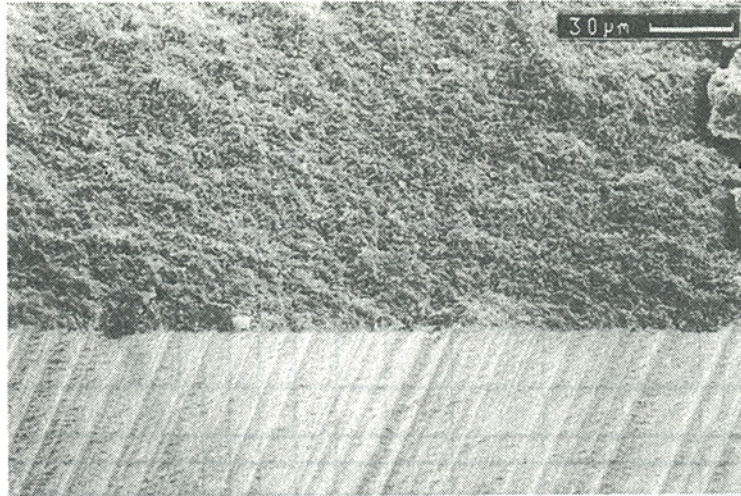
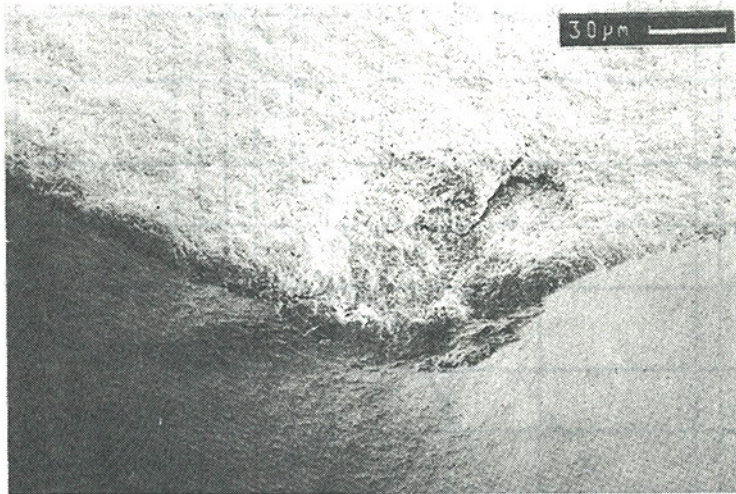
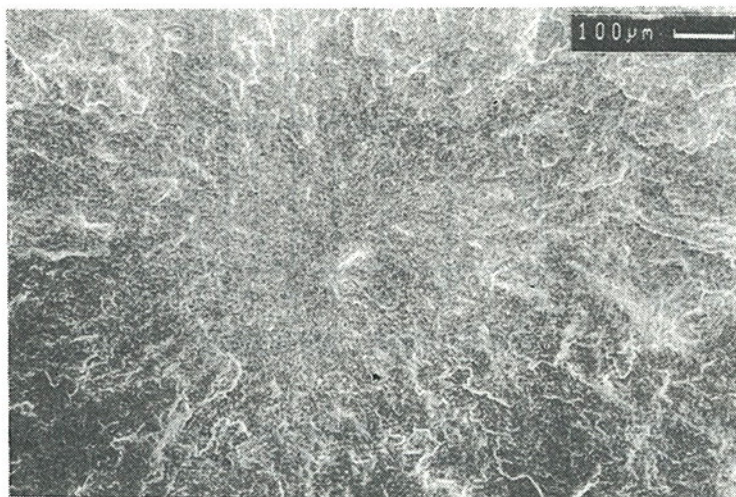
Figure 3.4. Examples of the fracture origins seen in the HIPed  $\text{Si}_3\text{N}_4$  analyzed by Participant 6. A) Specimen LP-37, Surface at surface? B) Specimen LP-29, Chip located at the edge. C) Specimen LP2-26, Inclusion located in the volume.

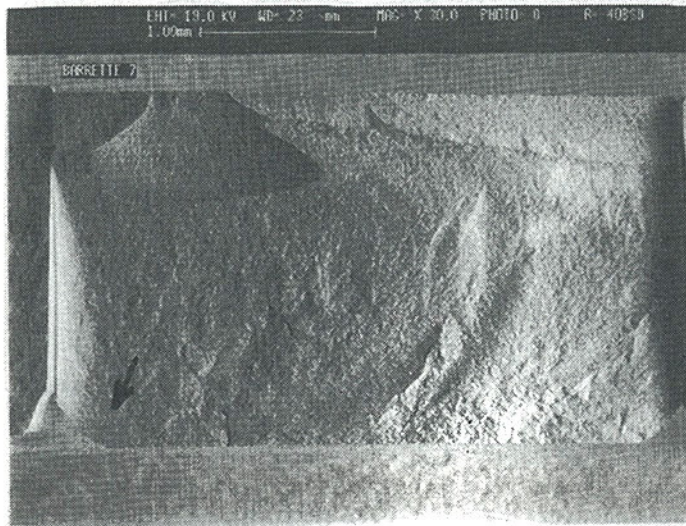
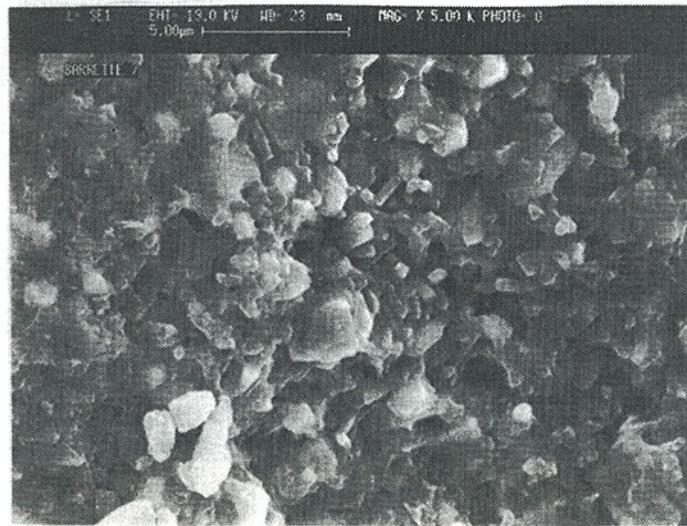
All twenty of the specimens were fractographically examined but only one of the fracture surface halves of each was examined. The Weibull plot, Figure 3.5, shows two possible origin populations. The participant identified the origin for specimens at the low end of the strength distribution ( $m = 1.4$ ) as cracks, (Figure 3.6) while the origin at the high strength end of the distribution ( $m = 23.3$ ) tended to be porous regions (Figure 3.7), or machining damage (Figure 3.8).

Figure 3.6. Example of an origin in a  $\text{Si}_3\text{N}_4/\text{TiN}$  specimen. Labeled by participant 10 as a crack.

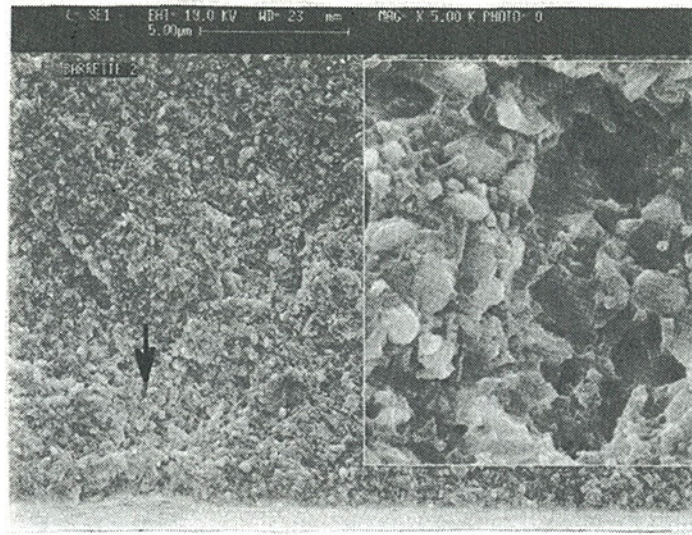
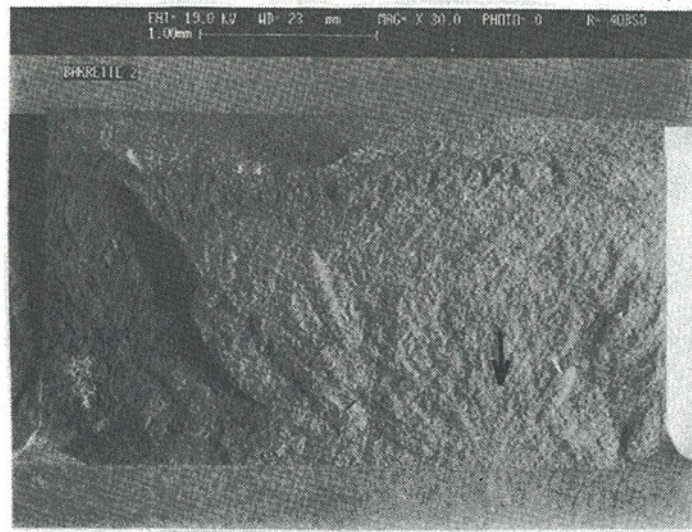
**SAMPLE N° 7**

MOR = 799.68 MPa

Figure 3.7. Example of an origin in a Si<sub>3</sub>N<sub>4</sub>/TiN specimen. Labeled by participant 10 as a porous region.

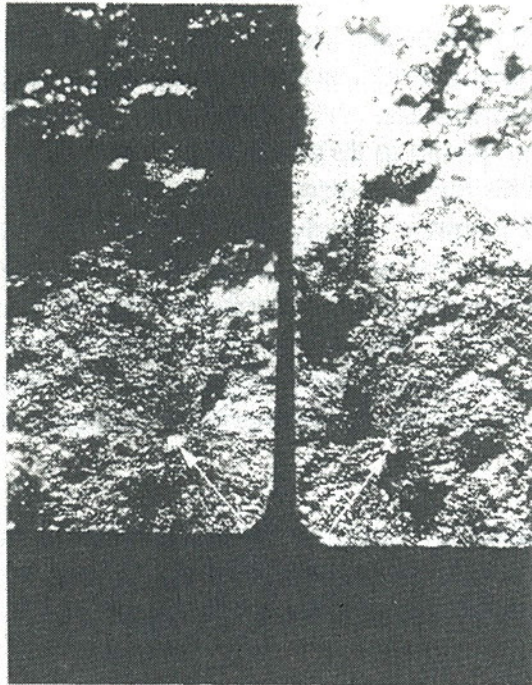
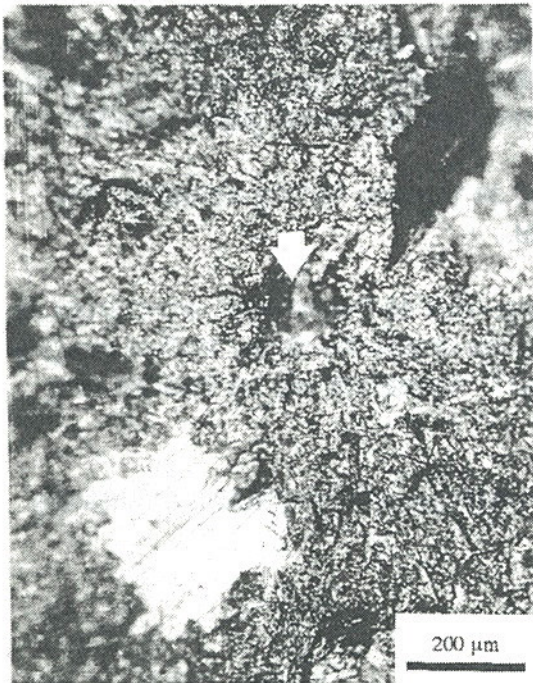
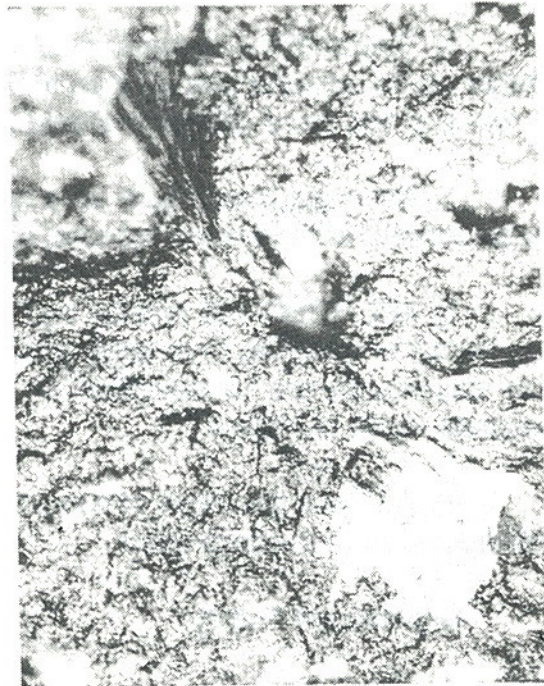
The first specimen was a sintered SiC. No processing details were available. The specimen had a fracture stress of 314 MPa. Optical examination of the fracture surface at 25X using grazing incidence illumination revealed that the origin was located near one of the corners, Figure 3.9A. At an optical magnification of 100X using mixed lighting the origin appears to be an agglomerate or an inclusion, Figure 3.9B and C, because there is a raised sphere on one half and a corresponding depression on the mating half. It was noted that even though there are large grains very close to this agglomerate these can not be the origin because river lines pointing to the sphere can clearly be seen in these grains. The origin size was estimated assuming an internal penny-shaped crack,  $Y = 1.13$ , a fracture toughness of  $3 \text{ MPa}\sqrt{\text{m}}$  and a local stress of 180 MPa (This stress took into account the distance the origin was from the tensile surface.). The estimated size ( $c$ ) is about  $218 \mu\text{m}$  which is about twice the reported diameter of the origin.

Figure 3.9. Origins in a sintered-SiC from participant 11. A) Optical photograph taken at 25X using grazing incident illumination. B) and C) Optical photographs of the mating halves of the fracture surface showing the origin. Taken at 100X under mixed lighting. Note large grains with river lines.

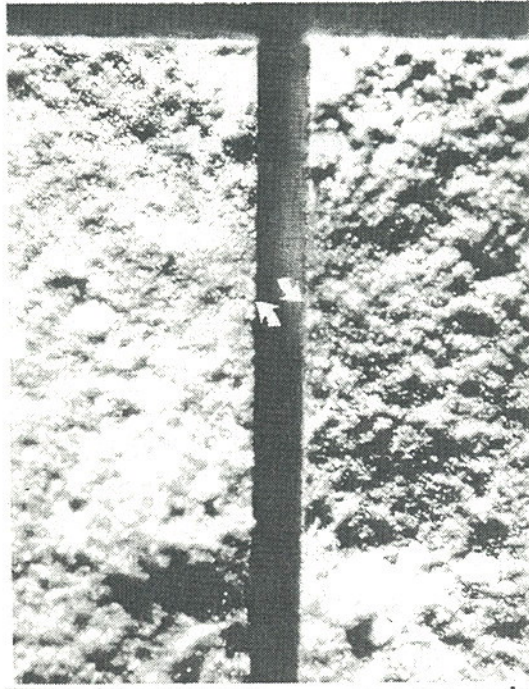
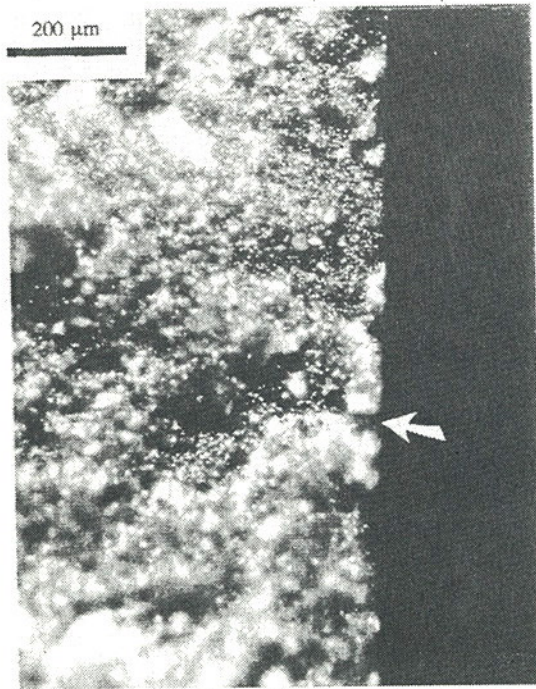
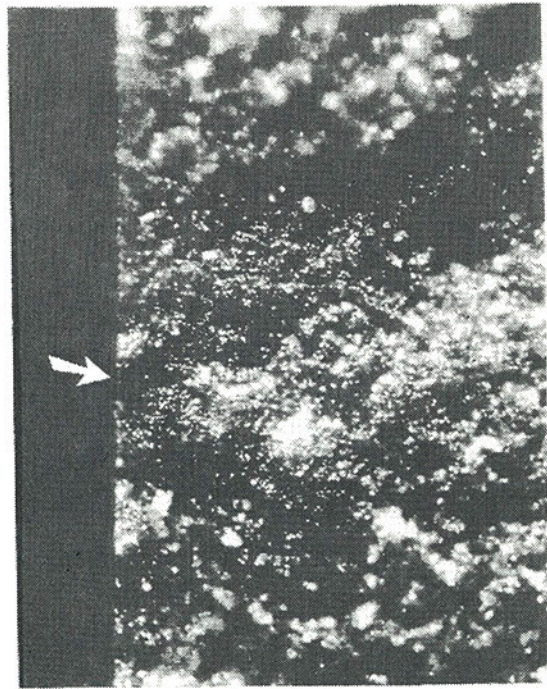
961 and was produced by Morgan Matroc, UK. The alumina grains are typically 3-4  $\mu\text{m}$  with the manganese and titanate phases appearing as sub-micron grains at the alumina grain boundaries. This specimen was machined from die-pressed, fired bars and tested in three-point flexure with a very fast crosshead speed of 5 mm/min. The fracture strength was 366 MPa and the toughness was about 4  $\text{MPa}\cdot\sqrt{\text{m}}$ . The origin is clearly at or close to the surface, Figure 3.10, thus  $Y$  was assumed to be 1.4 and the origin size estimated to be about 61  $\mu\text{m}$ . The participant states that there is a "crack-like defect" visible having approximately the right size. The participant further states "It is known that this material is prepared from spray-dried powder, and it is likely that the crack-like defects are elongated pores left by remnants of particles insufficiently crushed in pressing."

Although optical examination of these specimens was quite revealing it does not allow for complete characterization of the fracture origin. SEM analysis may have enabled the participant to reach a definitive characterization of the origin.

Figure 3.10: Origins in an alumina from participant 11. A) Optical photograph of the mating halves of the primary fracture surface, taken at 25X using grazing incident illumination. B) and C) Optical photographs of the mating halves of the fracture surface showing the origin. Taken at 100X under mixed lighting.
